**A Better Look Home Inspection**  
650 E. Soderberg Rd.  
Allyn WA 98524  
360-801-0950  
abetterlookhi@gmail.com abetterlookhi.com

**Inspection reference: 20191018**

## **Confidential Inspection Report**

**1234 N Street Rd**  
**Allyn WA 98524**

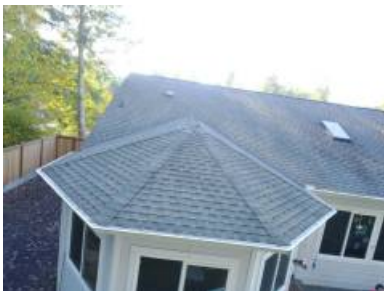
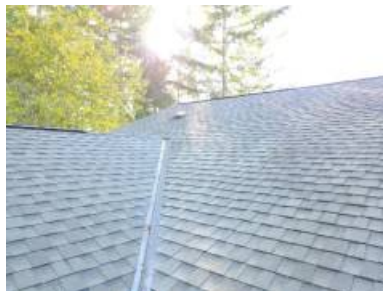
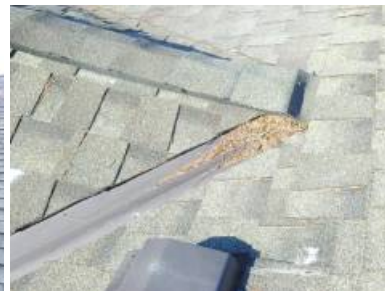
Gable.

Asphalt composition shingles. These consist of cellulose mat, asphalt impregnated with colored gravel on surface. Shingles are applied in horizontal rows.
